The *Challenger* Accident

Conspiracy Theories, Challenger, and Solid Rocket Boosters

Copyright ©2003 Jon Berndt

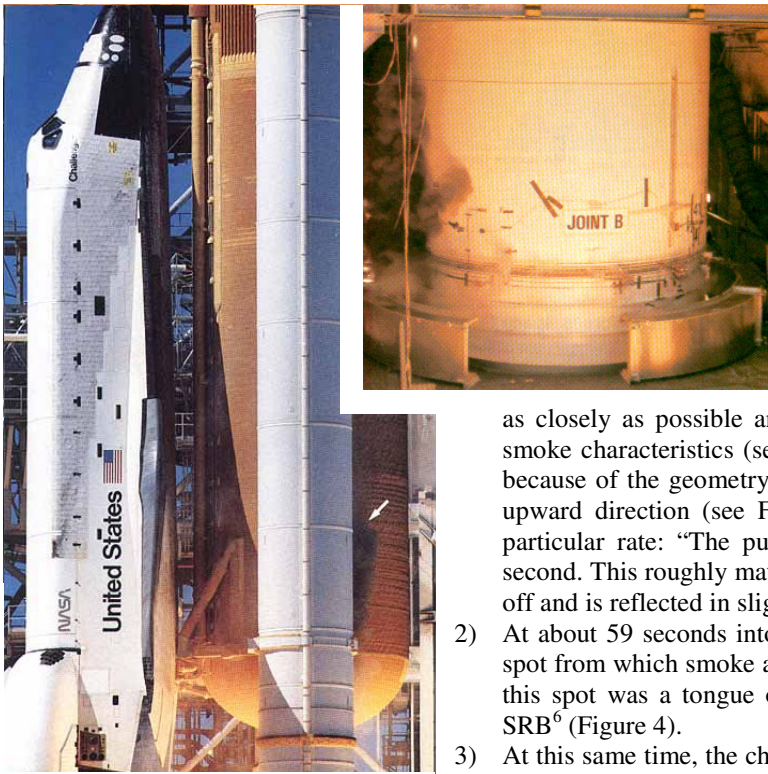
Figure 2 Black smoke at liftoff

- 1) At liftoff there were several releases of black smoke photographed near the aft field joint where two individually manufactured segments of the SRBs are mated, and nearest the side adjacent to the ET⁴. Later tests by Thiokol (the SRB manufacturer) duplicated liftoff conditions as closely as possible and found that a failed O-ring would exhibit the same smoke characteristics (see inset, Figure 2). The smoke is seen above the joint because of the geometry of the joint seal – the joint opens to the outside in an upward direction (see Figure 3). Additionally, the smoke was emitted at a particular rate: “The puffs appeared at a frequency of about three puffs per second. This roughly matches the natural structural frequency of the solids at lift off and is reflected in slight cyclic changes of the tang-to-clevis gap opening.”⁵

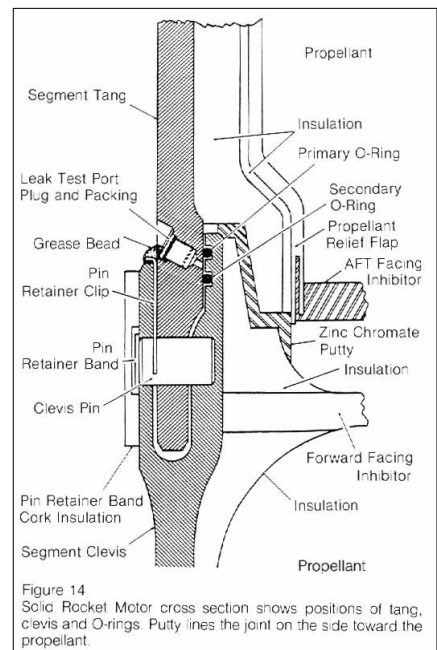
Figure 3 SRB Field Joint

Figure 14
Solid Rocket Motor cross section shows positions of tang, clevis and O-rings. Putty lines the joint on the side toward the propellant.

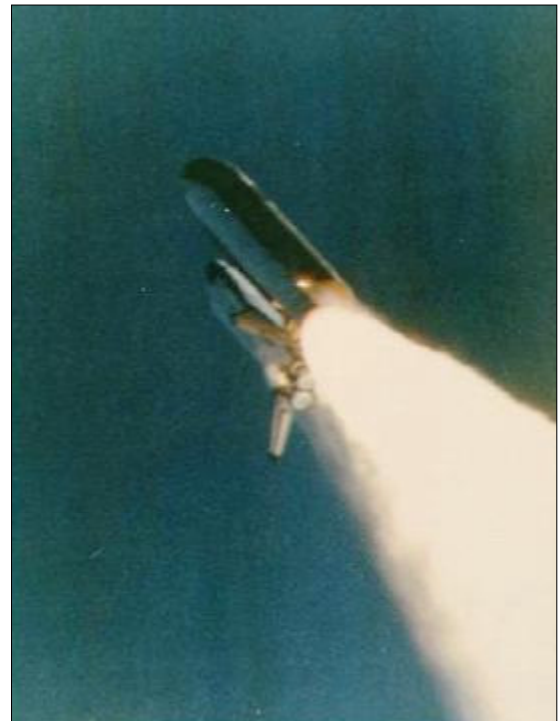
- 2) At about 59 seconds into the flight, a bright spot appeared at or near the same spot from which smoke appeared to emanate in item 1, above. Analysis showed this spot was a tongue of flame escaping from the aft field joint of the right SRB⁶ (Figure 4).

Figure 4 Right SRB breach after 59 seconds

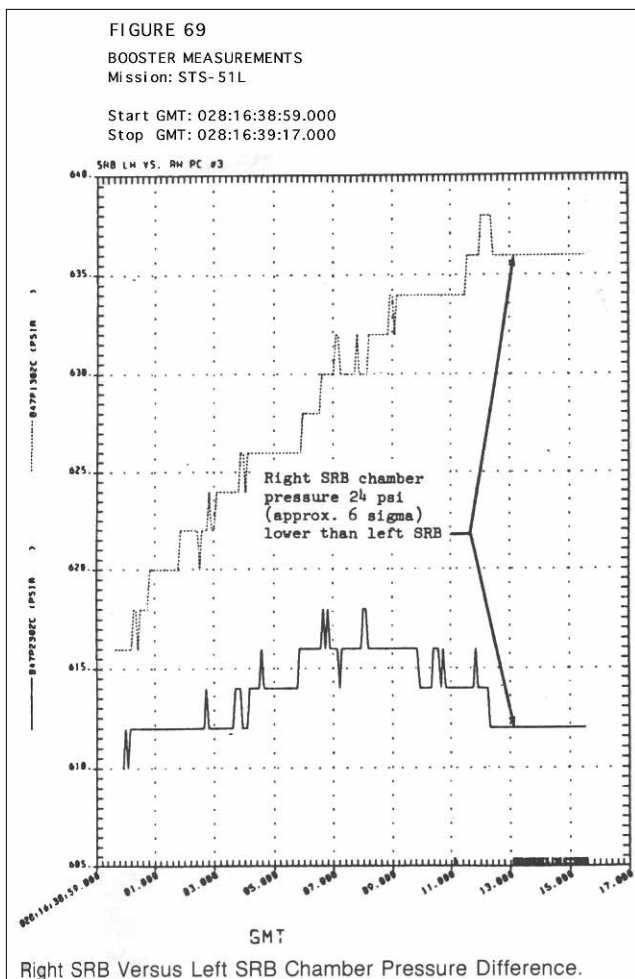
- 3) At this same time, the chamber pressure trace for the right SRB began diverging from nominal (Figure 5).
- 4) Debris recovered from the ocean floor and identified via serial number and other means showed the right SRB to have suffered a burnthrough from the inside out at

Figure 5 SRB chamber pressure plots

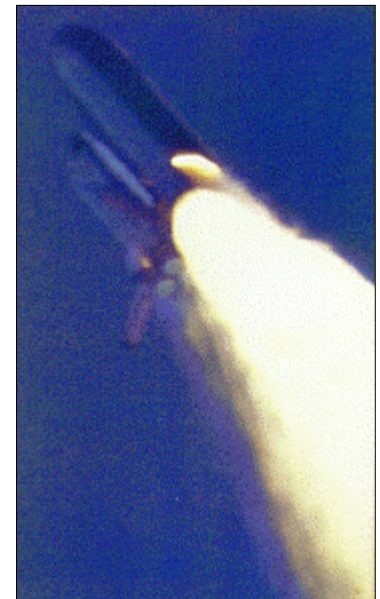
As mentioned before, at 59 seconds into the launch, the PC Report describes – and the photo and video record displays – a breach in the right SRB¹⁵ at the aft field joint at or near the same spot where a suspected O-ring failure was viewed at launch. At 59 seconds, the right SRB chamber pressure abruptly began to differ from that of the left SRB (see Figure 5). The plume seen in the photo and video record left its own smoke contrail, and the plume itself was of similar luminance to the main SRB exhaust plumes. As time progressed this plume was seen to grow. The breach plume also appears to be reflecting off the OMS "stinger" where the RCS nozzles are located (Figure 6).

Figure 6 Growing plume

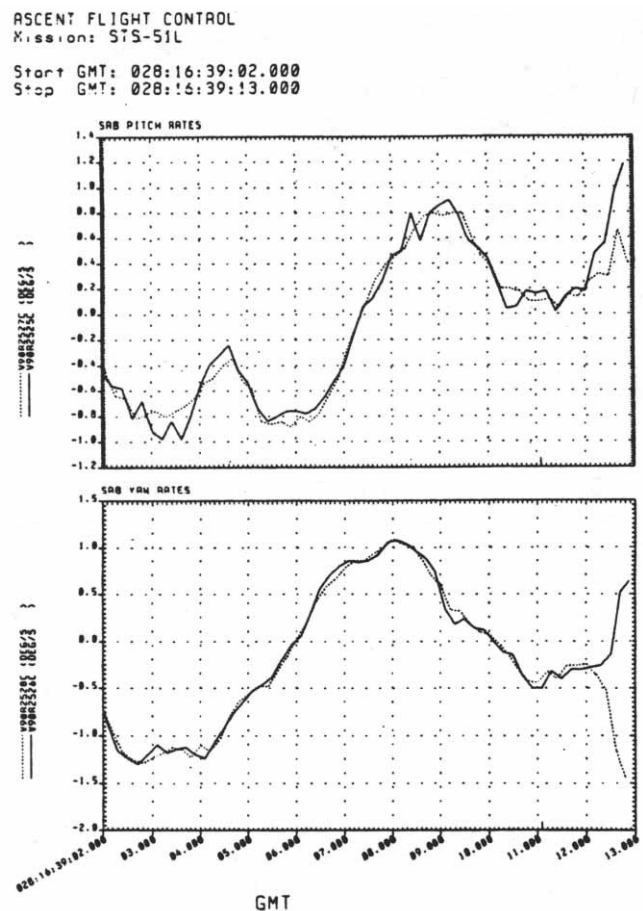
Figure 7 Pitch and Yaw Rate Divergence, SRBs

At 72 seconds after liftoff the yaw and pitch rate traces for the two SRBs begin to diverge. This indicated that the SRBs were changing their alignment with respect to each other. There is a fine point to interpreting this data, however. The question can

SRB Yaw and Pitch Rate Divergence.

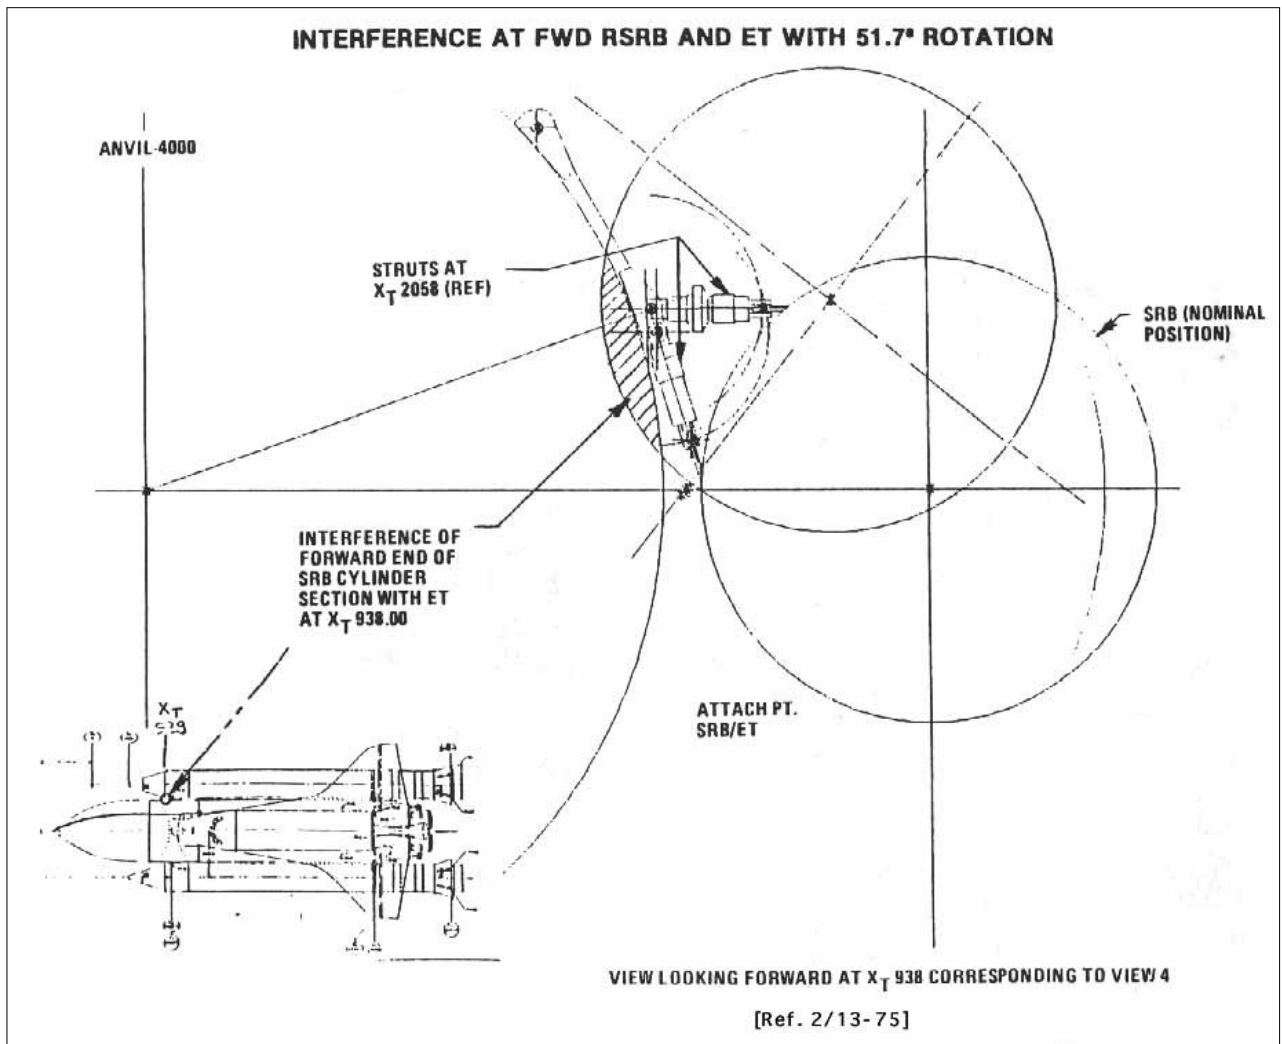
This is a computer-drawn picture [see Figure 8, next page] of the launch vehicle looking down on top with the solid rocket booster released from its lower link. The evidence that we have is that we have lost the load pad at that link. If that results, then the right-hand solid rocket booster then is free to pivot about its forward attachment point and one of the remaining aft attachment points. This is consistent with maintaining a data source from the solid rocket boosters, because the integrity of everything going on in the solid rocket boosters, the data flows through the top aft link. What is hypothesized here, and is supported by the analysis, is that the lower left-hand or the lower link has failed, the solid rocket booster has both rolled about that new hinge line so it has a new pitch and yaw attitude. That is what we measure from the flight data. When it does that, it impacts the inner tank region, as shown here on this drawing, between the LOX tank and the hydrogen tank, there. It impacts it just at the lower portion of the frustum of the right-hand cone of the solid rocket booster. If I could have the next chart, please.

Figure 8 SRB rotation dynamics following lower aft strut failure

The right SRB rotated about the new hinge line created by the upper aft attachment and the forward SRB attachment, and it eventually rotated so far that it the top portion of the SRB cylinder contacted the ET intertank area and damaged it. The idea that the SRB rotated out at its base and "*nosed* into" the ET is wrong.
